A PHOTOGRAPHIC SURVEY OF THE
WILMINGTON & WELDON RAILROAD CORRIDOR

VOLUME I

(Ruins at Wilmington, NC, 2000-2001)

James C. Burke

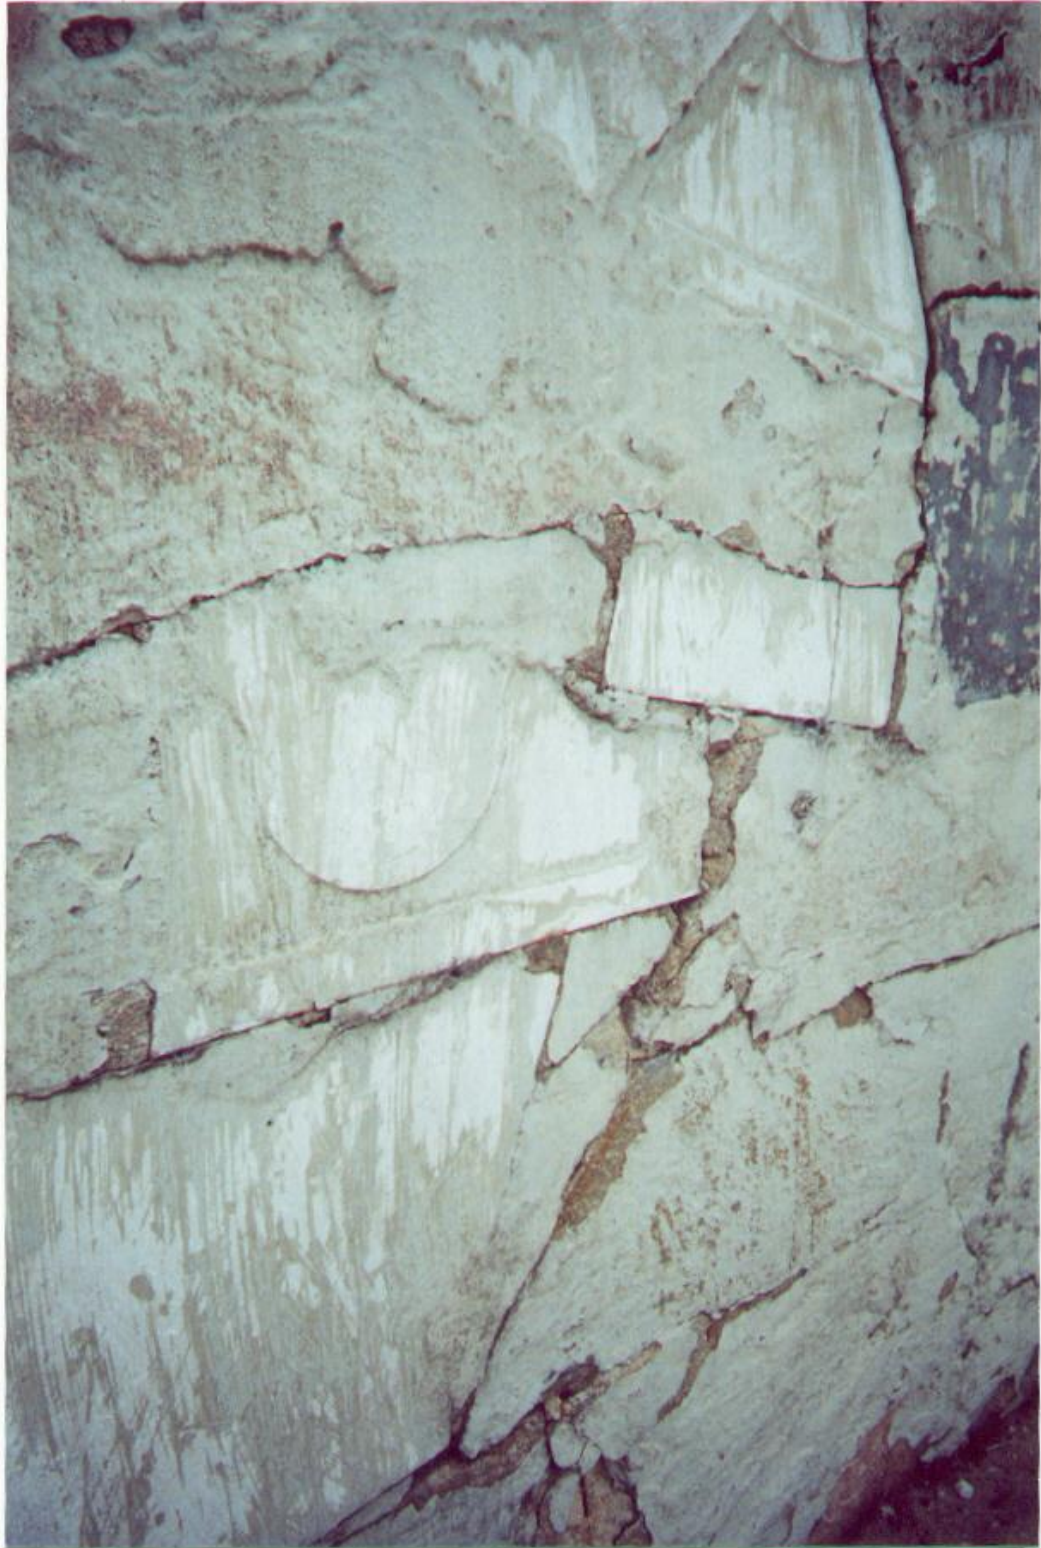
Figure 4

In this section of the wall facing Nutt Street, details of tile patterns are visible.

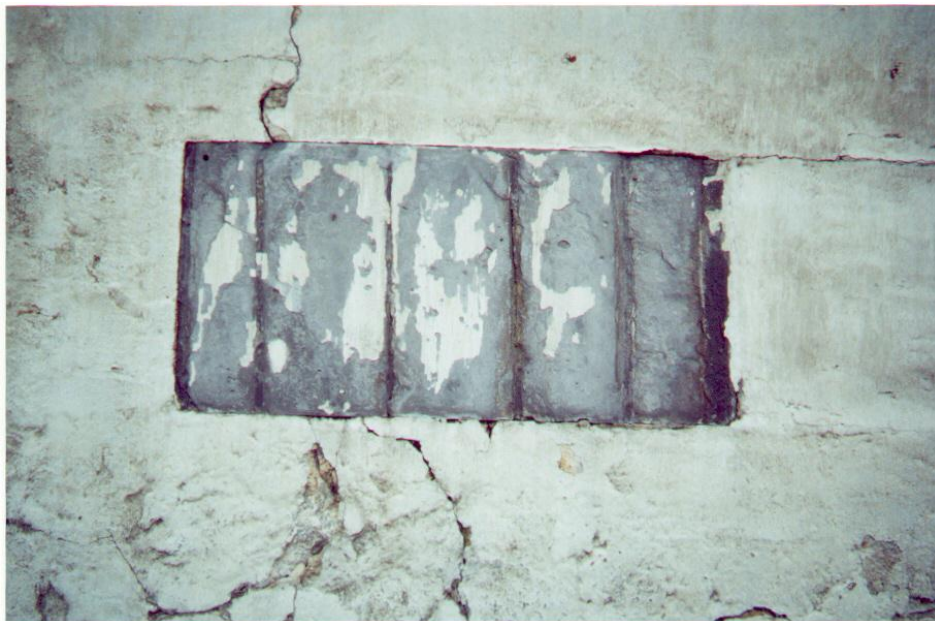
Figure 6

This photograph is of a section of the same wall where roofing slates are visible. Holes are drilled in a few of these slates. For example, notice the hole in the upper left corner of the first slate on the left.

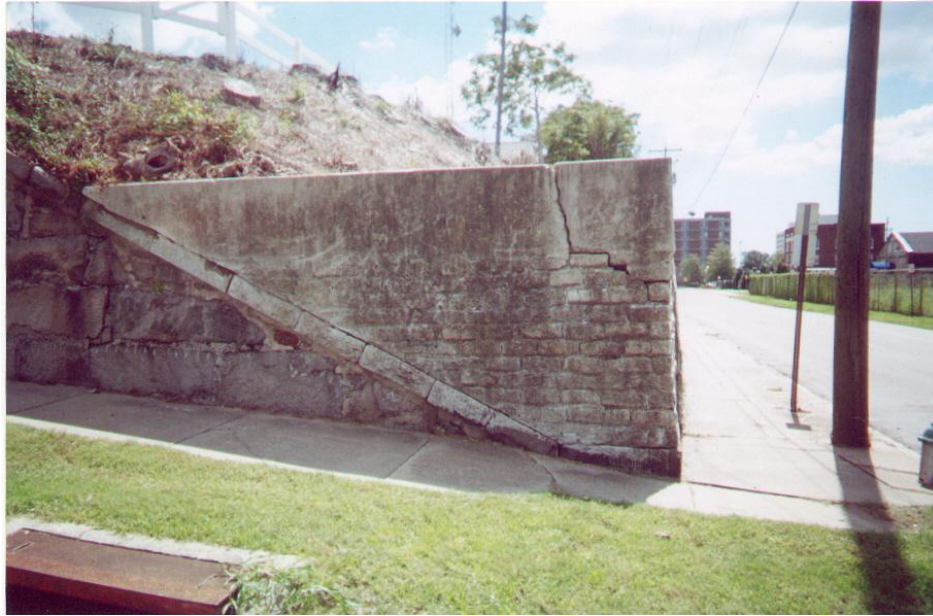
Figure 8

New wall constructed on the older stone wall as seen at the corner of Hanover Street and Nutt Street.

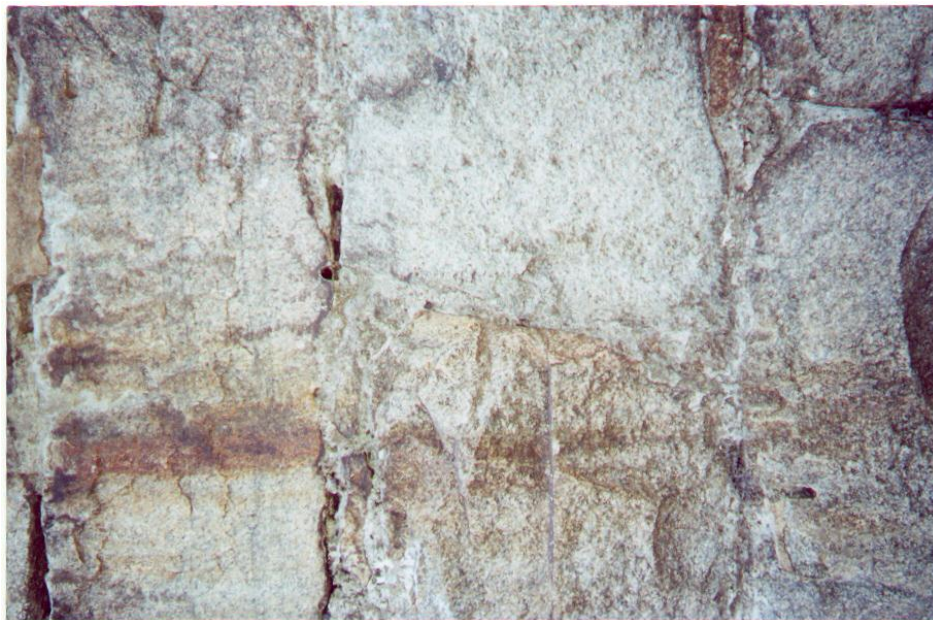
Figure 9

Close-up of granite in older section of same wall mentioned in Figure 8.

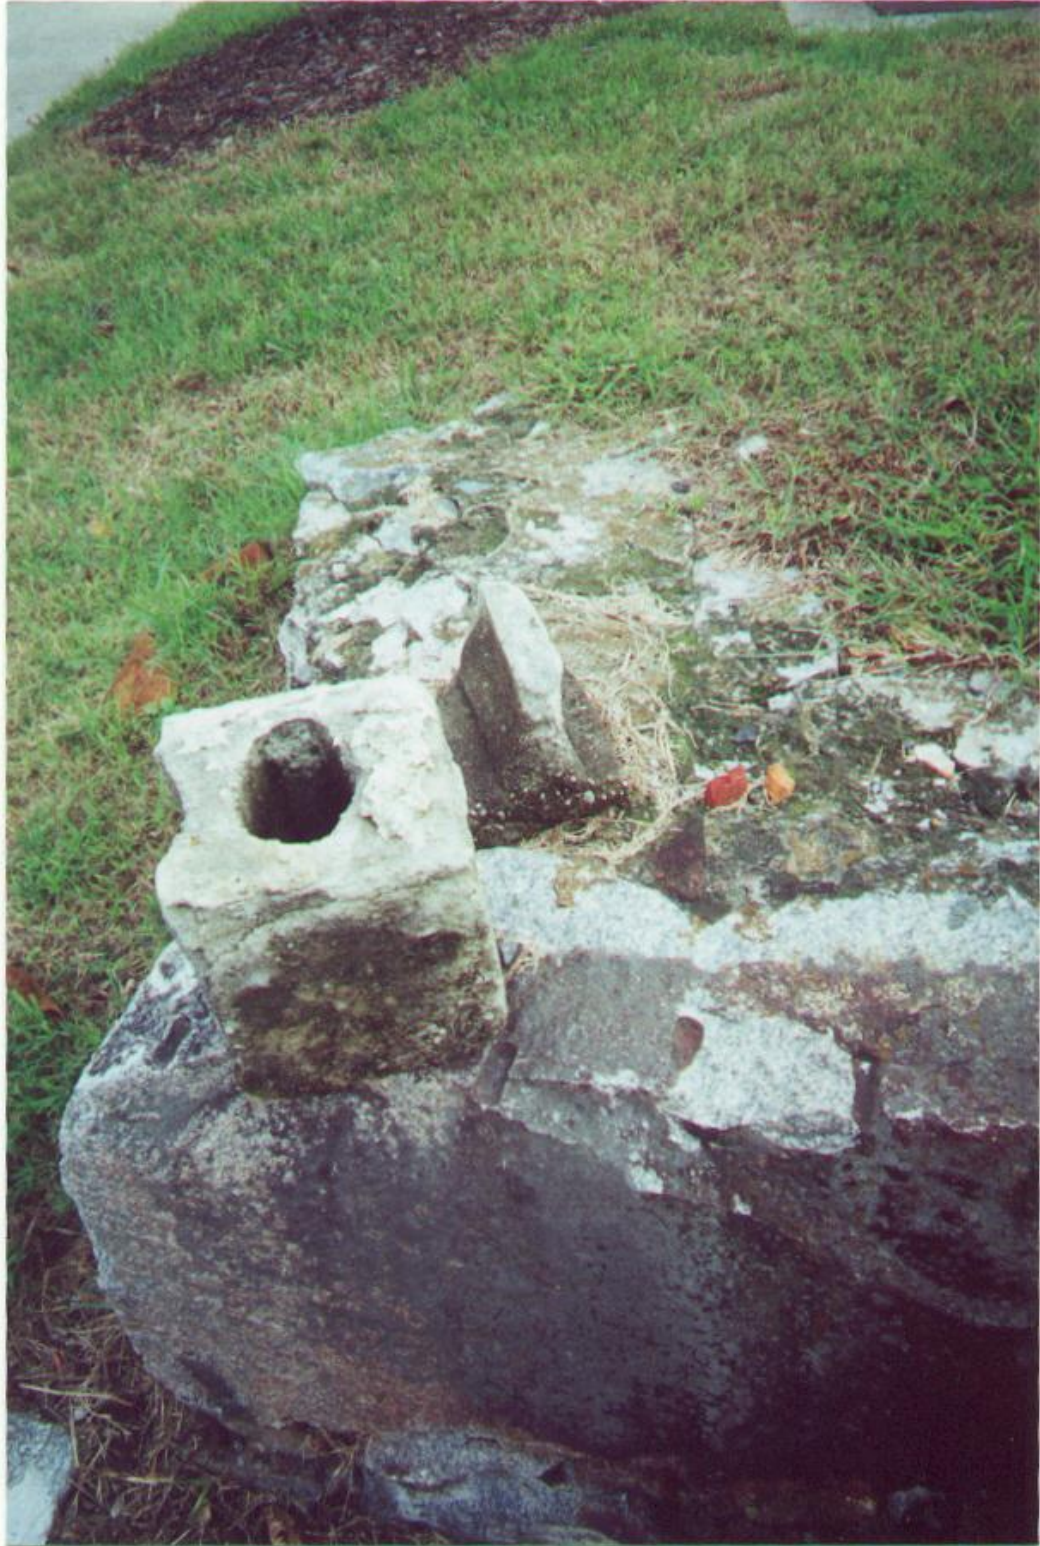
Figure 10

The northeast corner of Block 245 at the intersection of Hanover and Front Streets. Note how the stone section of this wall is buried.

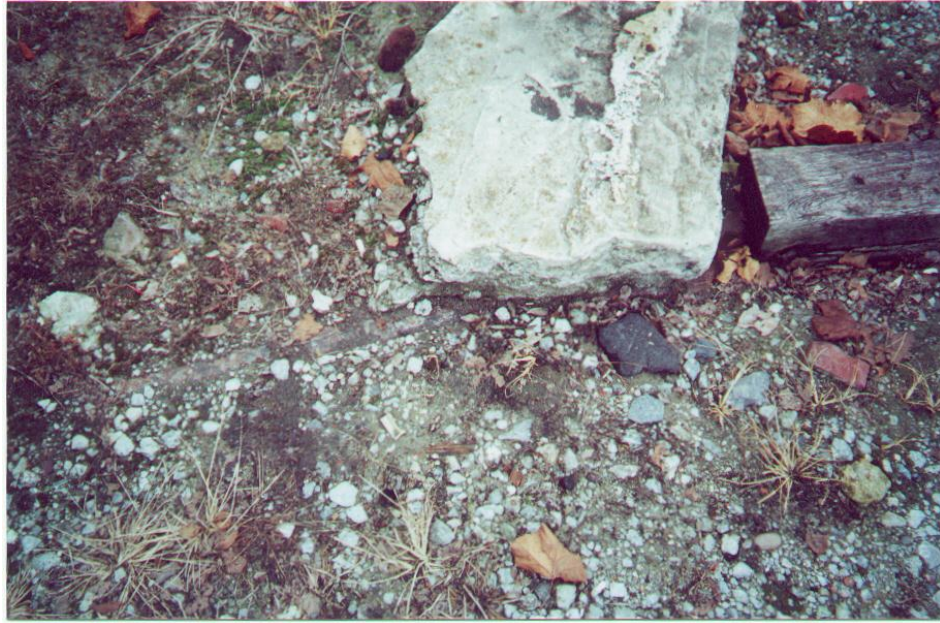
Figure 11

Stonework and an iron rail in Block 231, in front of retaining wall where a public park is located.

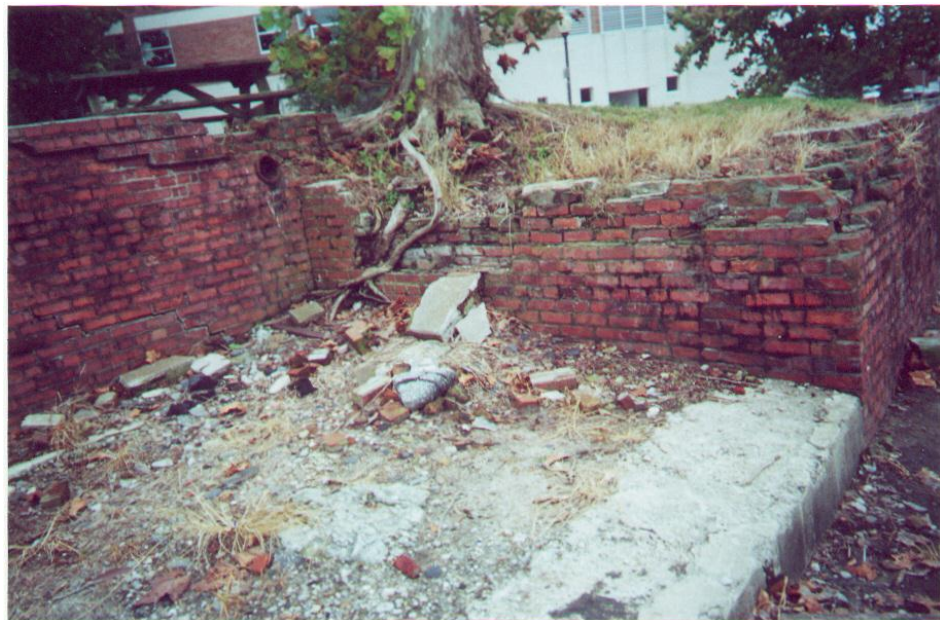
Figure 12

This is the retaining wall at the site of the public park.

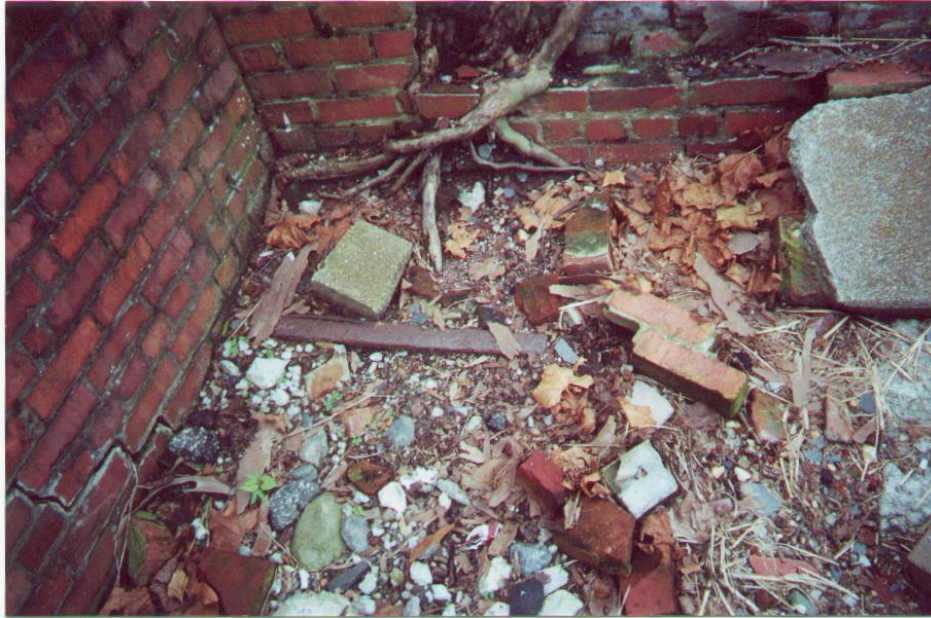
Figure 13

Mixed debris at retaining wall mentioned above. Note half-buried rail.

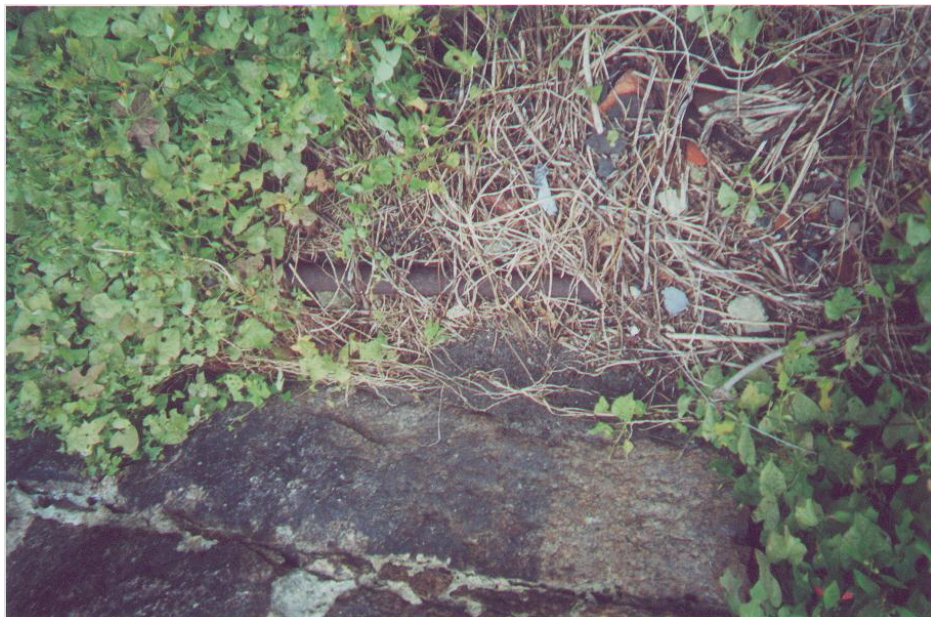
Figure 14

Metal and stone debris at same place mentioned above.

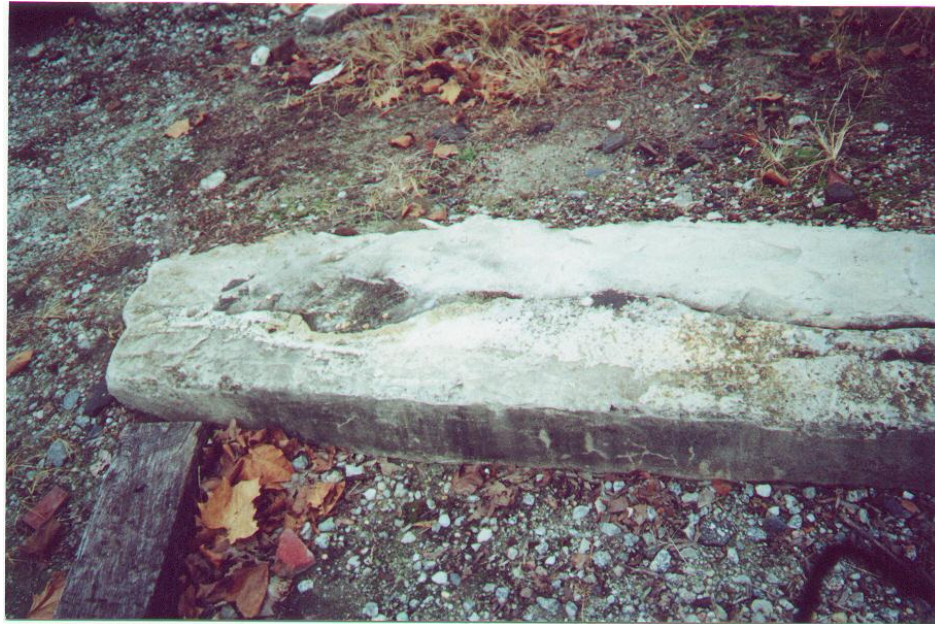
Figure 15

Section of a concrete slab in the same area (below the public park at the corner of Red Cross and Nutt Streets.

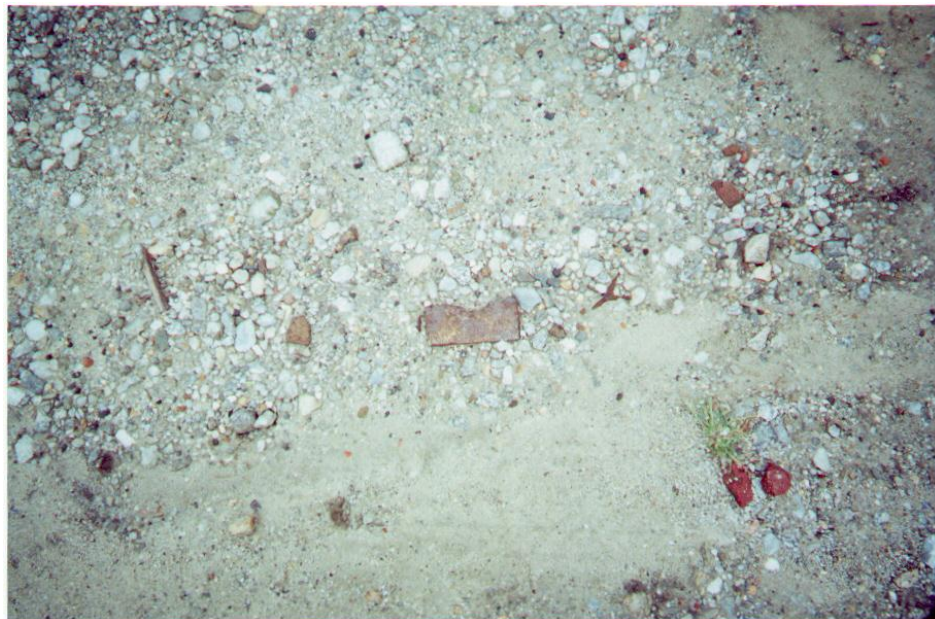
Figure 16

Iron railroad material can be found on the surface of the parking lot on Block 231 near Nutt Street.

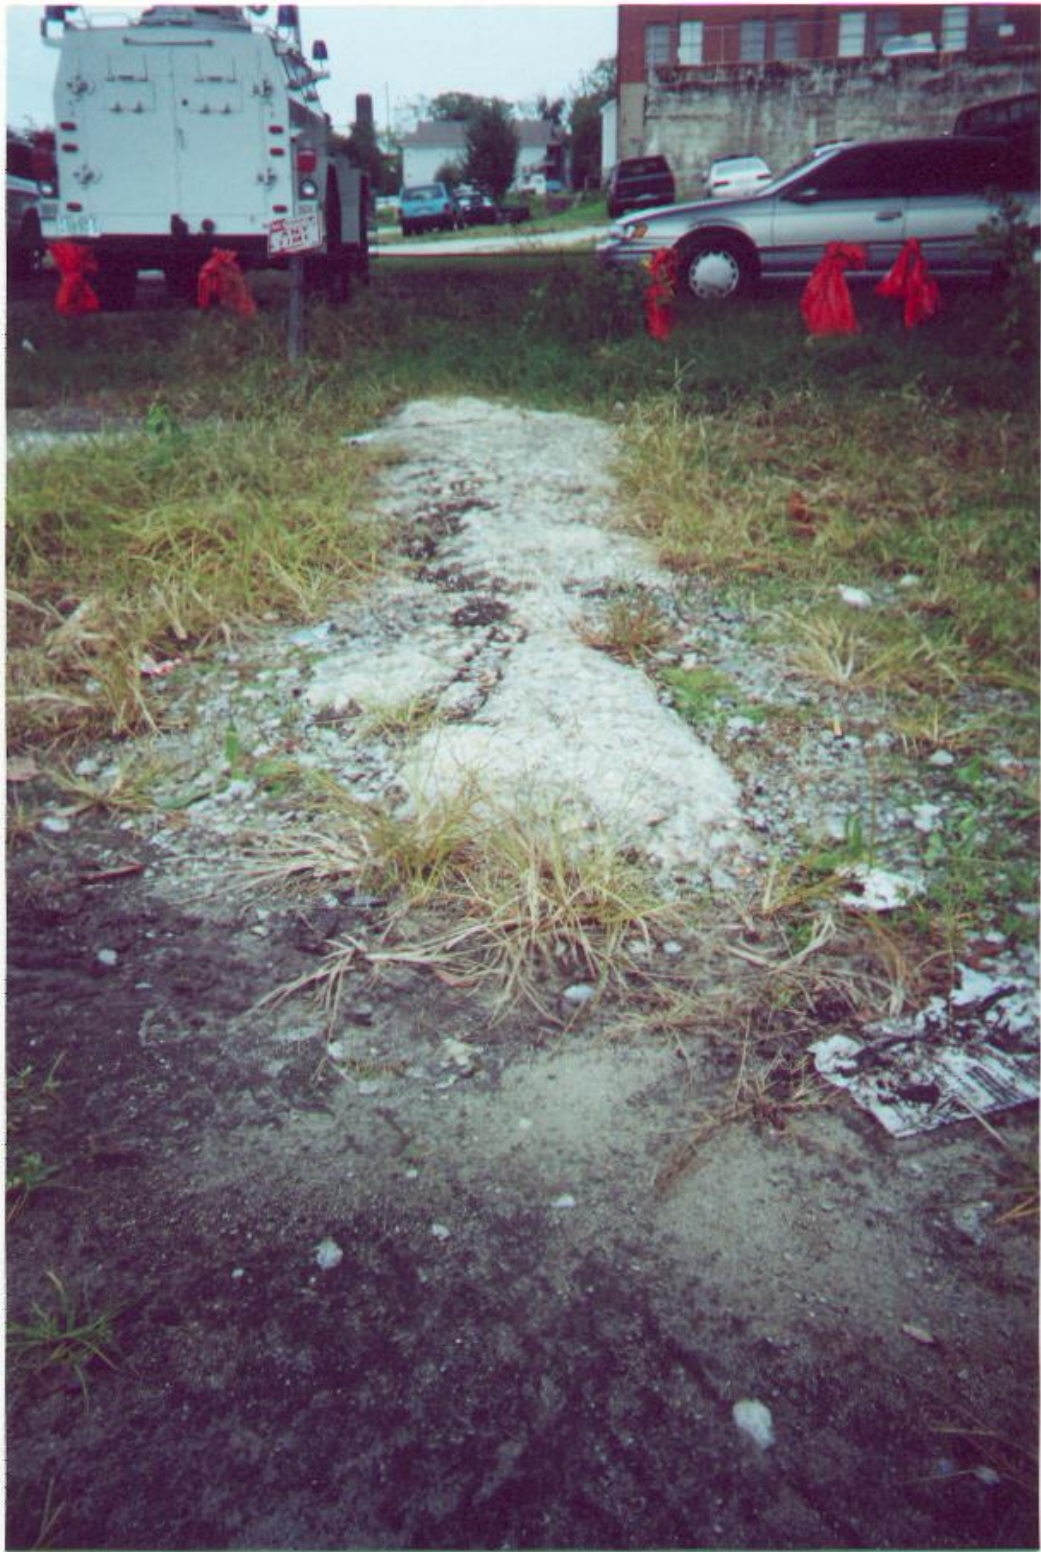
Figure 17

Concrete footing for old ACL concourse under Front Street Bridge.

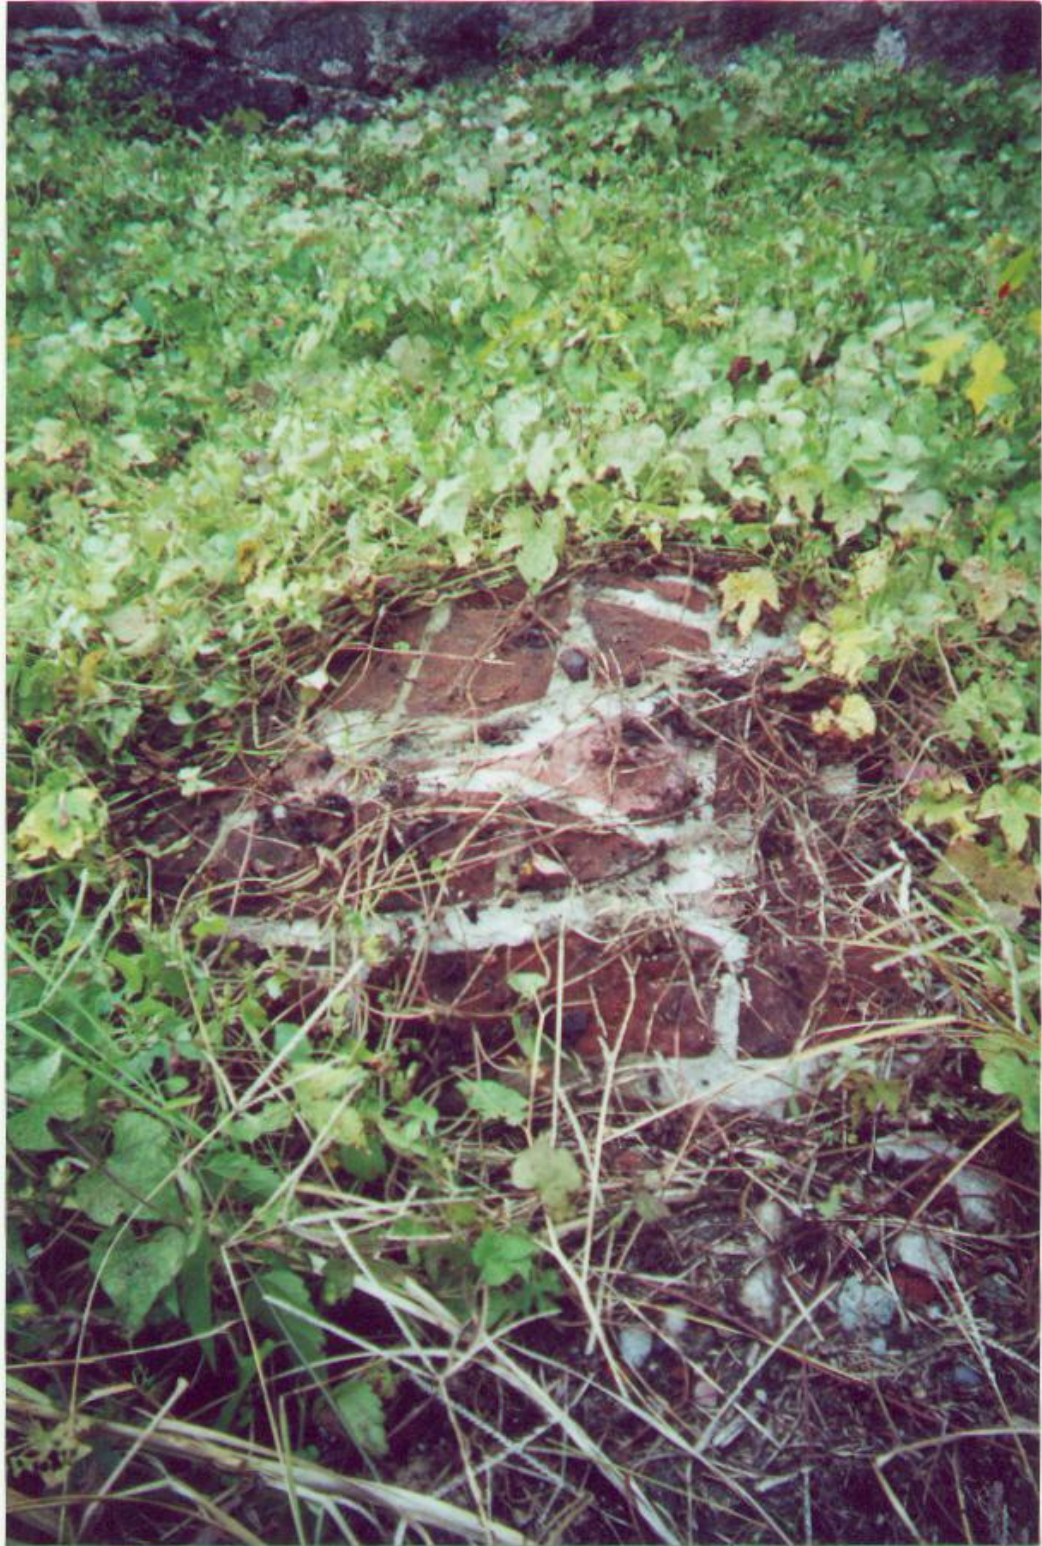
Figure 18

Unusual cut brick footing with iron connectors embedded in mortar in parking lot of Block 231 near the granite wall.

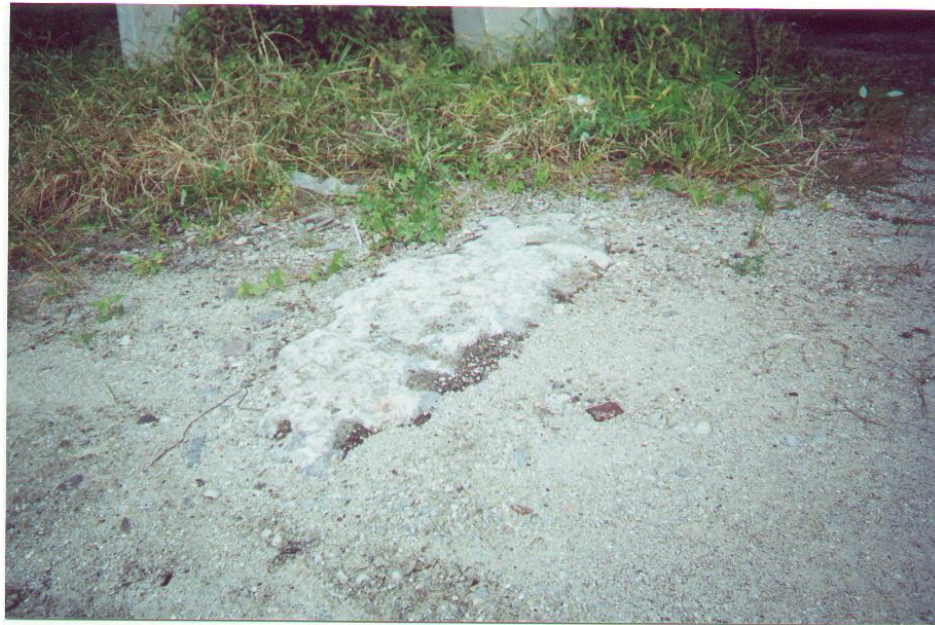
Figure 19

Another concrete footing for old ACL concourse under Front Street Bridge.

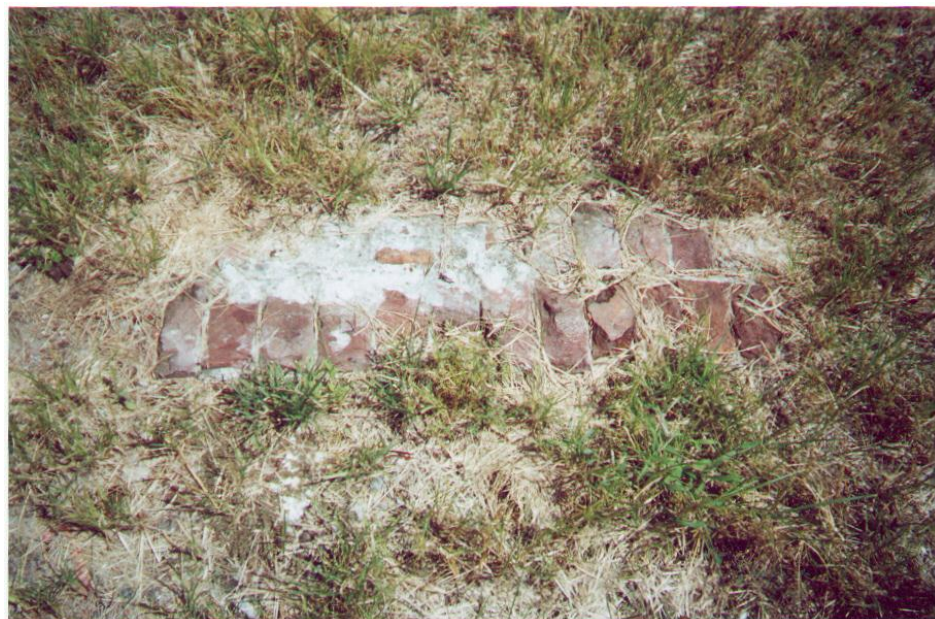
Figure 20

Buried section of foundation or footing for stairs in the parking lot of Block 231 near the granite wall.

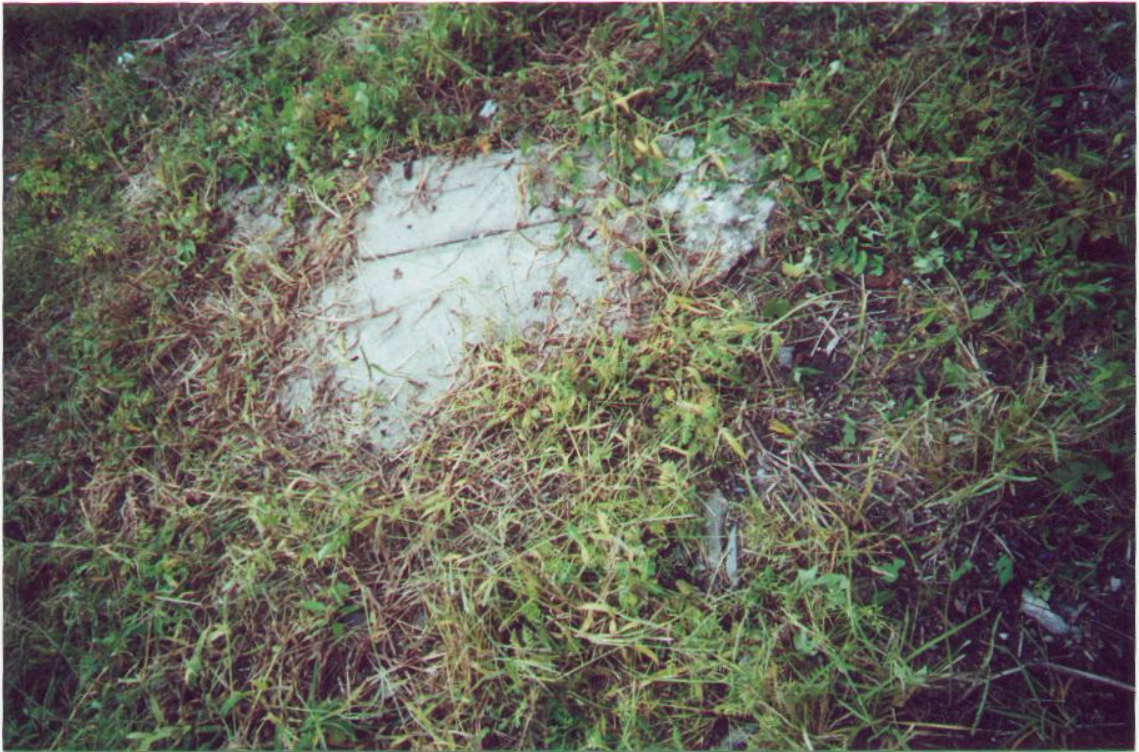
Figure 21

Section of concrete slab at the same place as Figure 20.

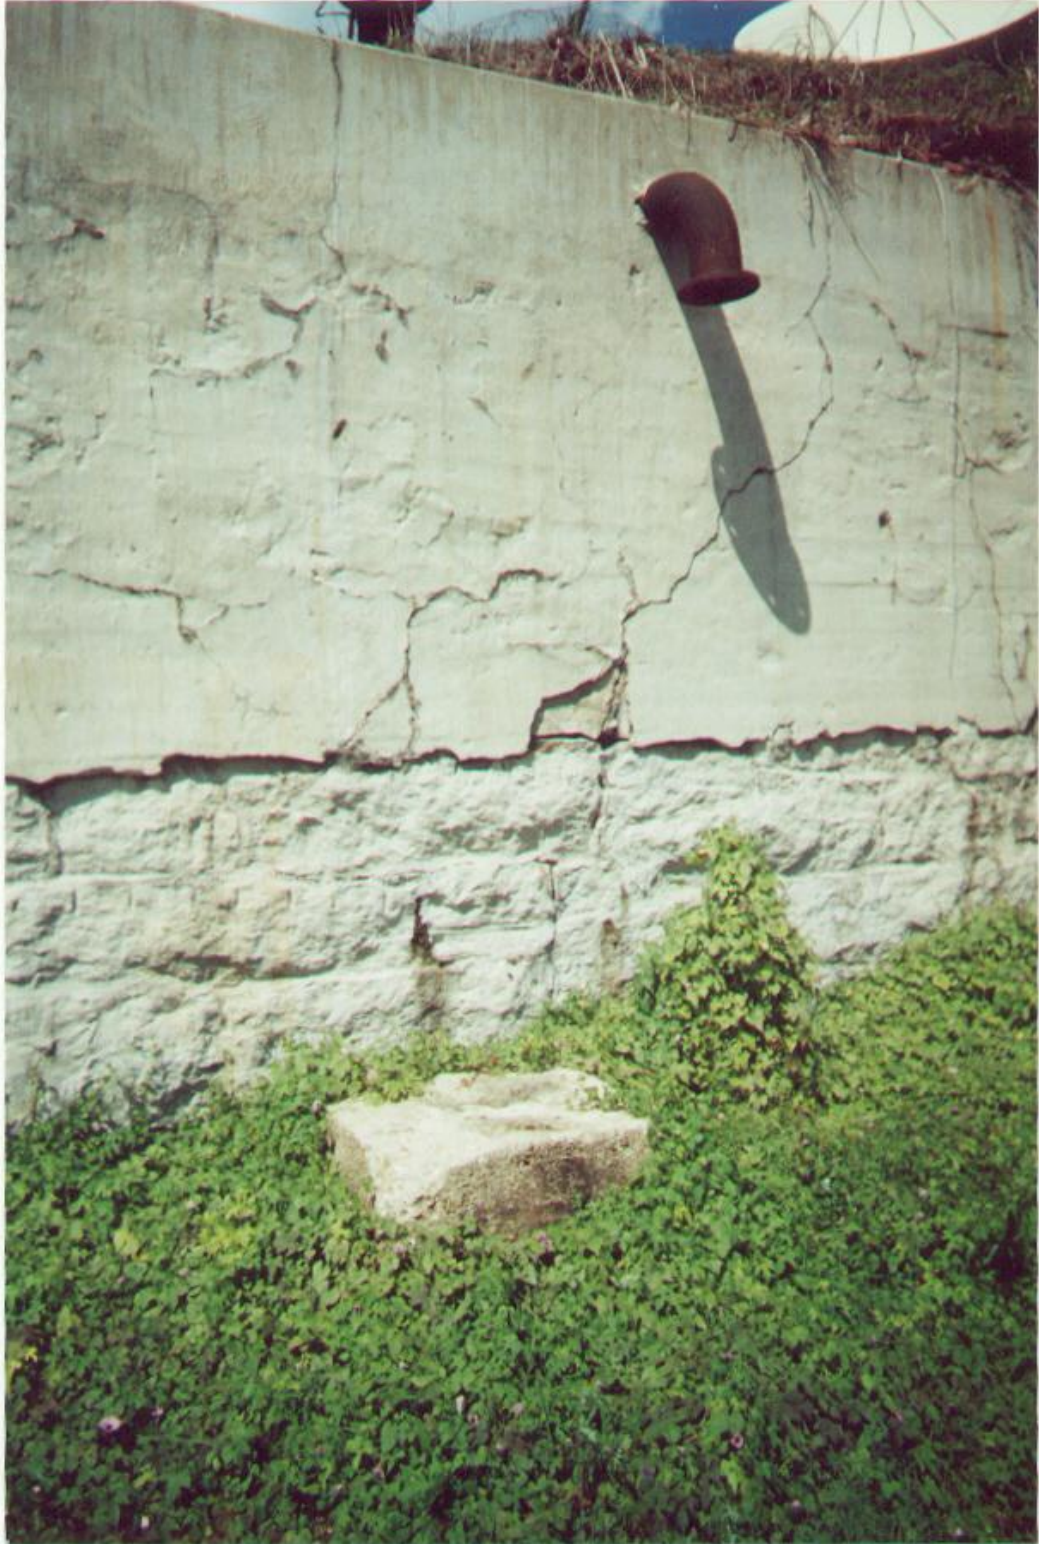
Figure 22

Retaining wall in Block 231 near TV 3 dishes. Note the pipe that once when to a railroad water tower above wall.

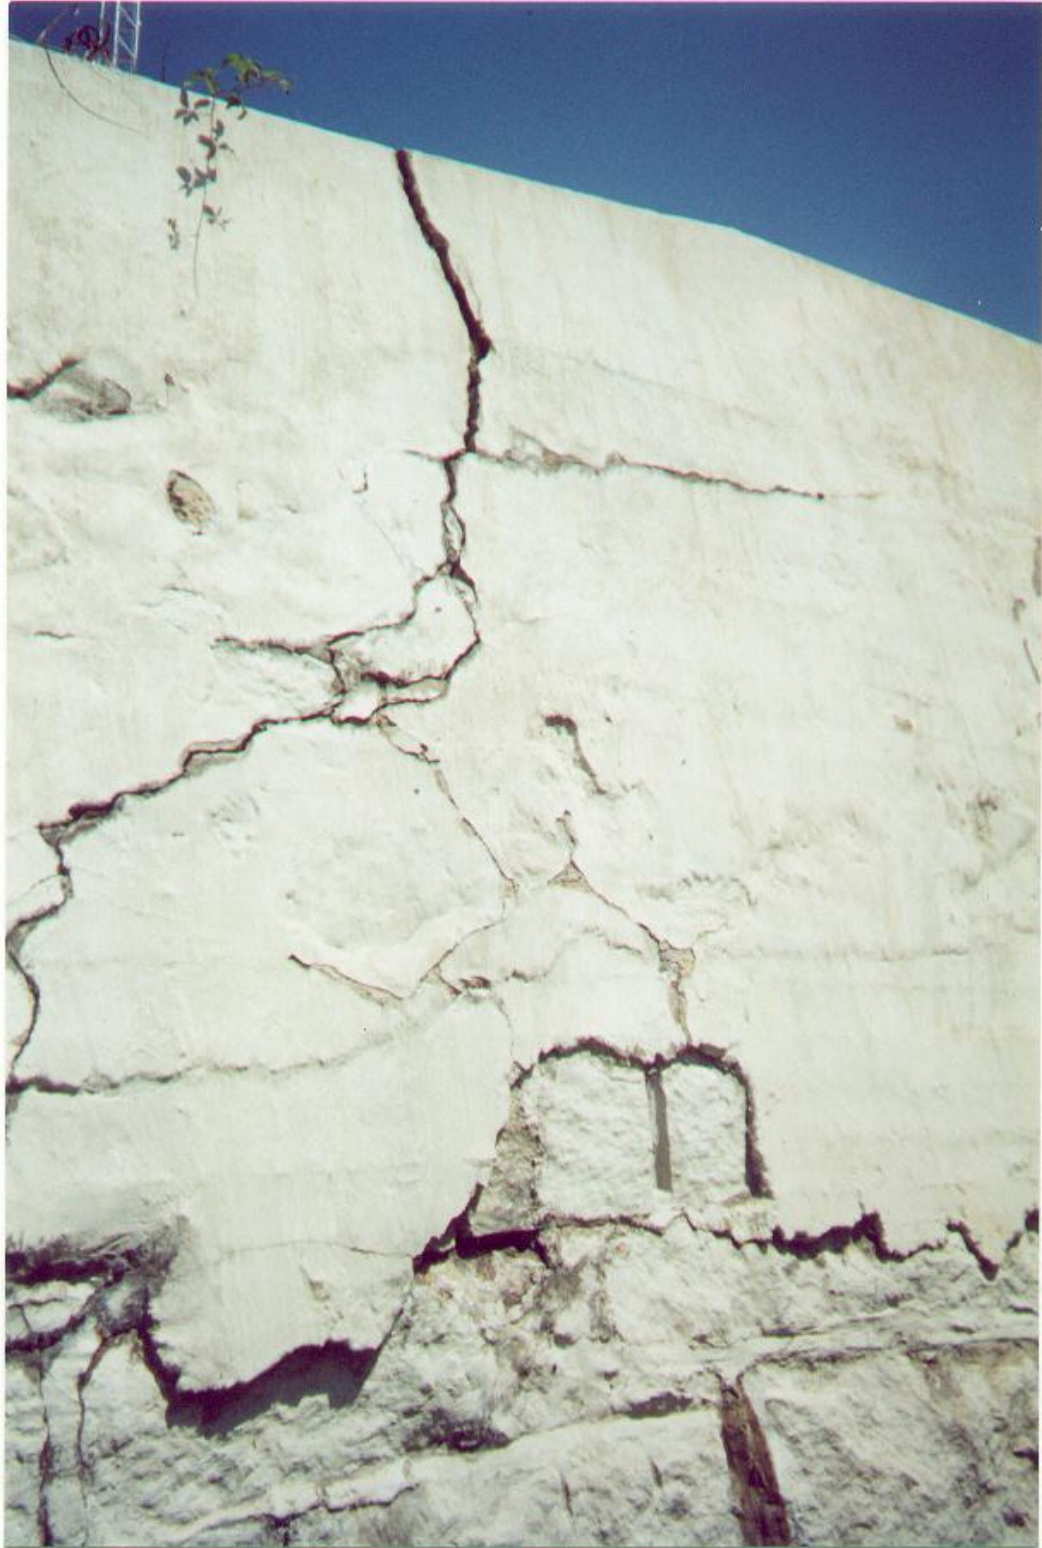
Figure 23

This photograph shows some details of the same wall, crowned with concrete blocks.

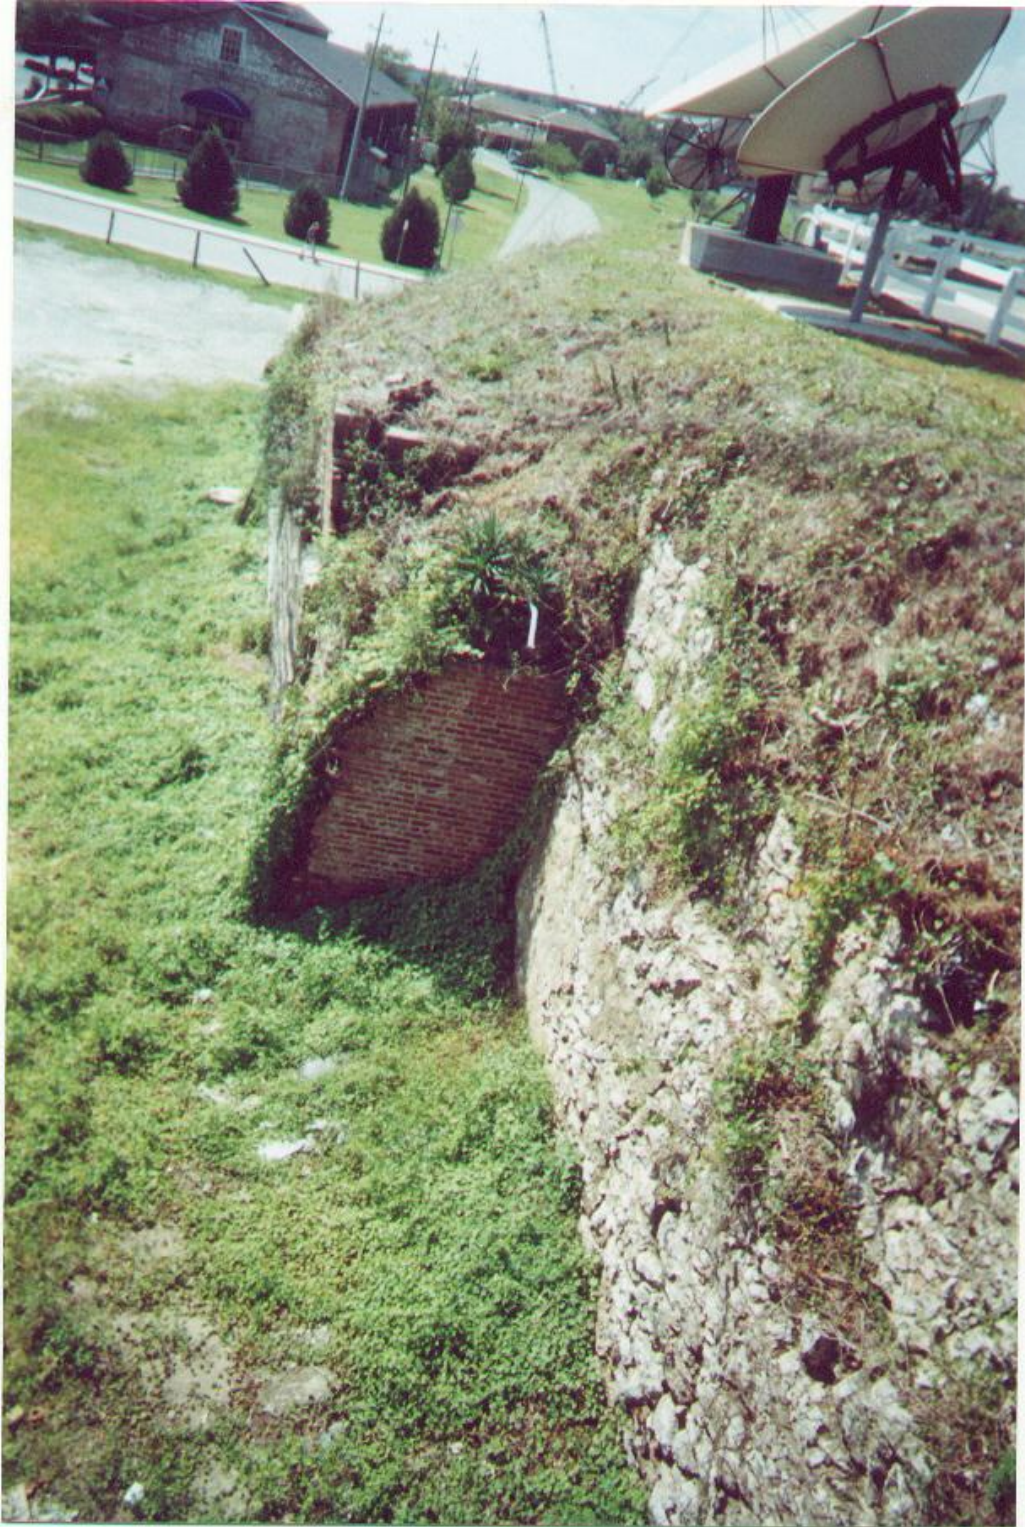
Figure 31

The brick walls are shifting apart.

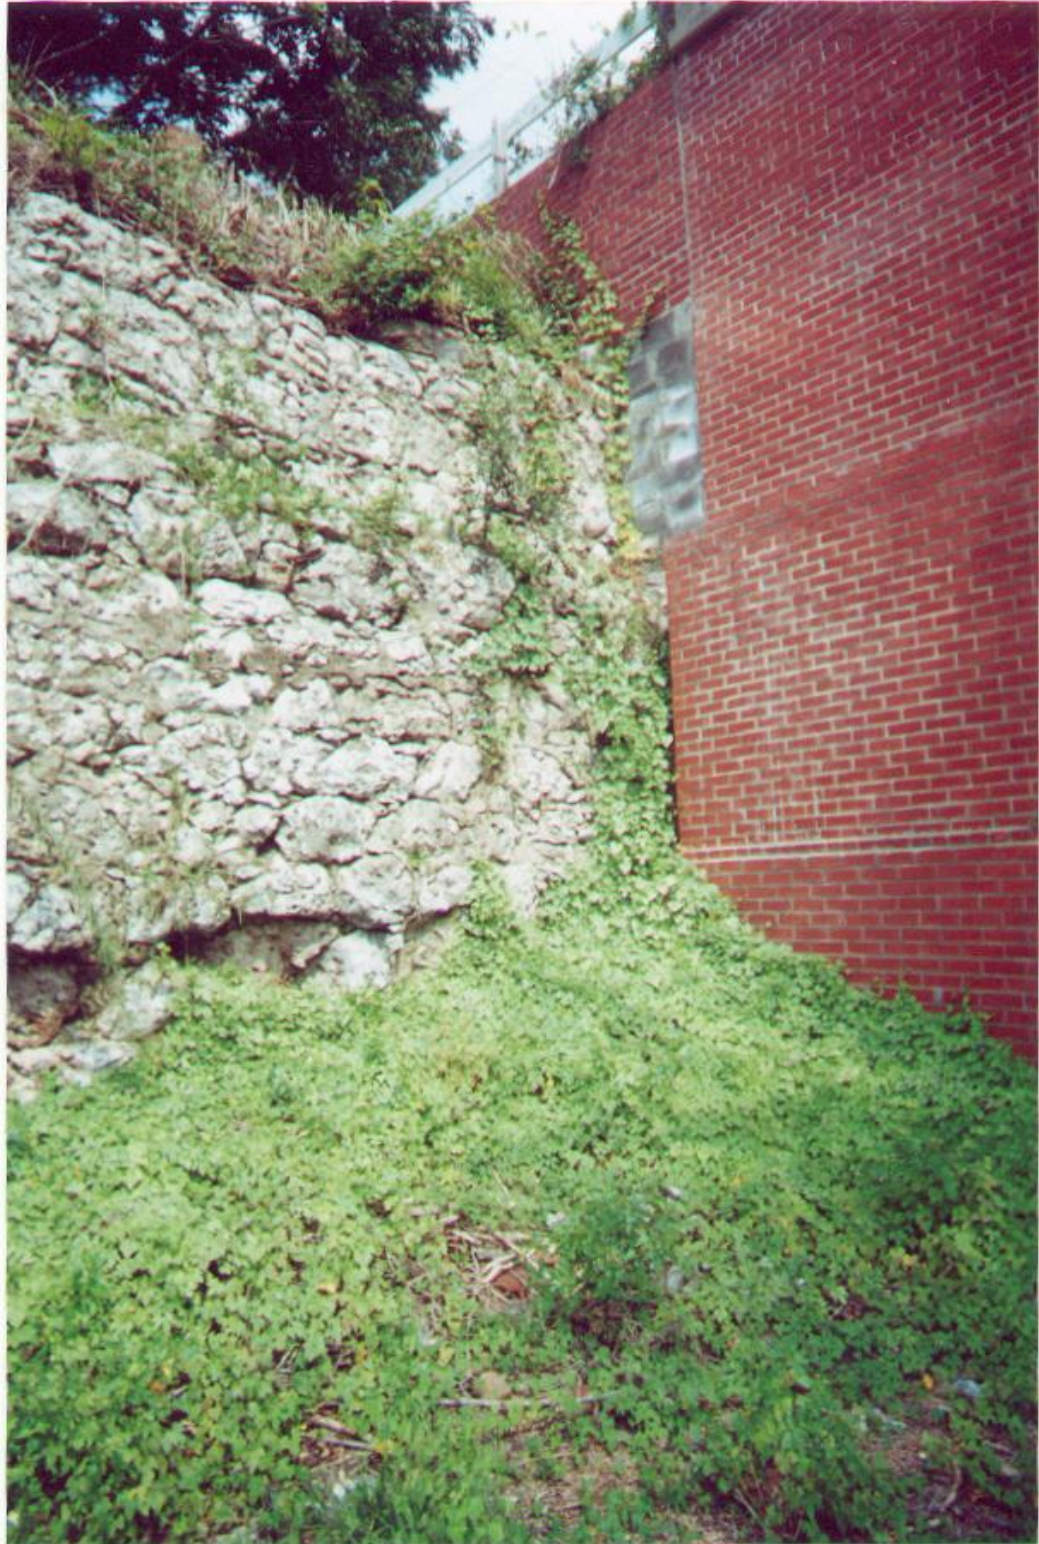
Figure 32

Conglomerate wall recedes behind brick foundation of the Front Street Bridge.

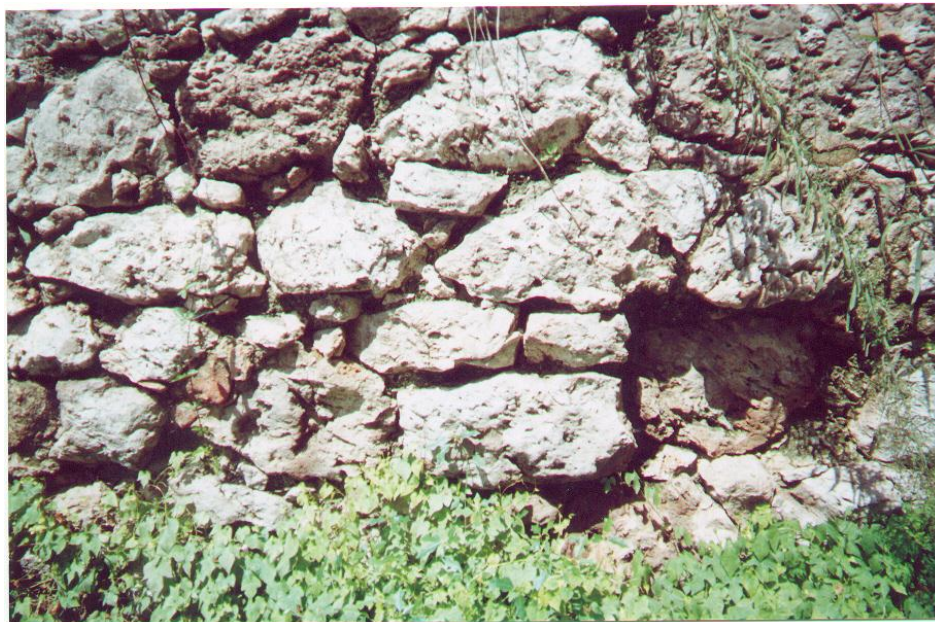
Figure 33

This is a close-up of conglomerate material.

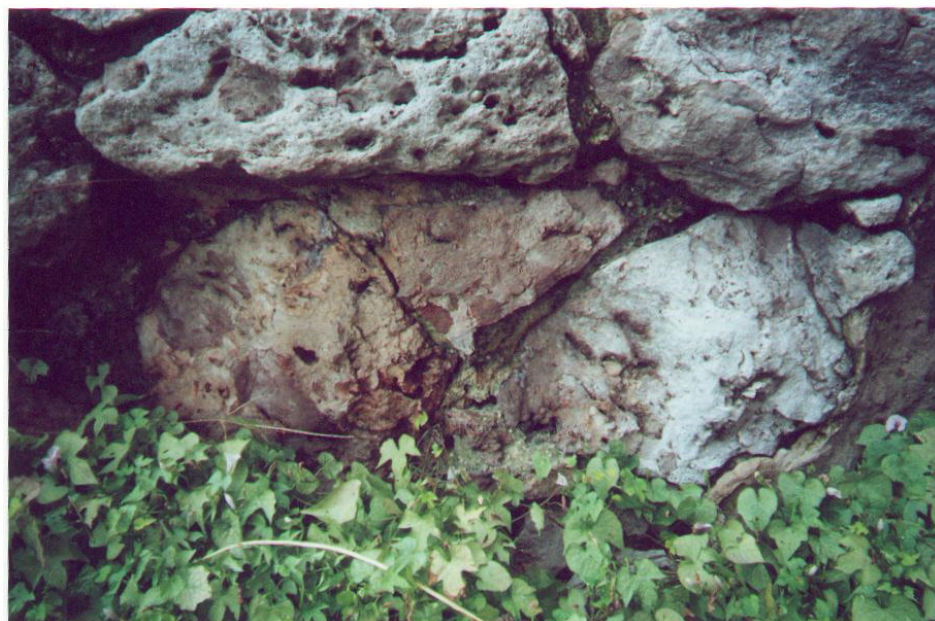
Figure 34

Brick fragments are mixed in conglomerate.
